**AGENDA**  
**BLOOMINGTON TRANSPORTATION COMMISSION**  
**REGULAR MEETING**  
**TUESDAY, JUNE 19, 2018 4:00 P.M.**  
**COUNCIL CHAMBERS, CITY HALL**  
**109 EAST OLIVE STREET**  
**BLOOMINGTON, ILLINOIS**

**MINUTES  
BLOOMINGTON TRANSPORTATION COMMISSION  
REGULAR MEETING  
TUESDAY, MAY 15, 2018 4:00 P.M.  
COUNCIL CHAMBERS, CITY HALL  
109 EAST OLIVE STREET  
BLOOMINGTON, ILLINOIS**

Intersection Modifications

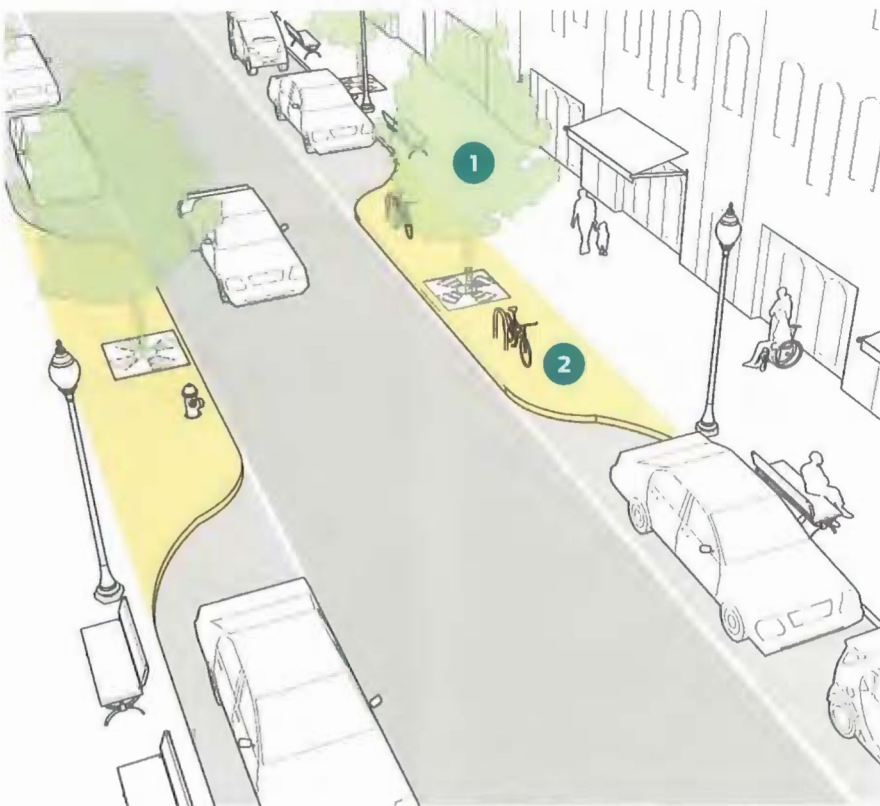
## Pinchpoint

Curb extensions may be applied at midblock to slow traffic speeds and add public space. When utilized as a traffic calming treatment, midblock curb extensions are referred to as "pinchpoints" or "chokers".

- 1 Plant street trees on curb extensions aligned to the parking lane to narrow the overall profile of the roadway. Before installing street trees on the curb extension, assess surrounding utilities to ensure that the trees' roots will not damage underground infrastructure.

- 2 Bicycle racks can be combined with curb extensions, especially in areas where bicycle parking is insufficient or demand for long-term or short-term parking is unmet.

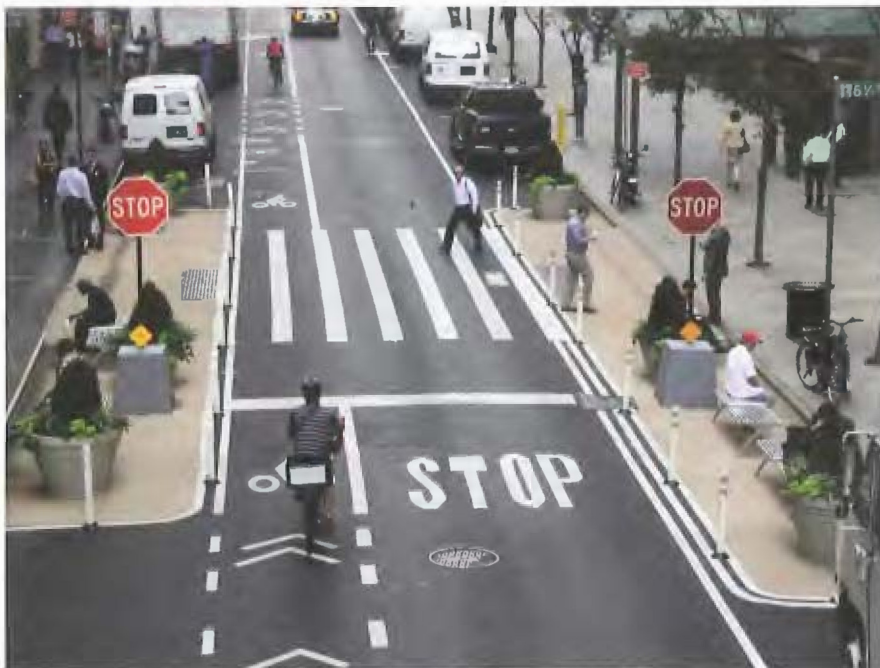
#### NEW YORK, NY

6 1/2 Avenue in New York City connects a series of privately-owned public spaces that cut midblock through Midtown. The visibility of crossing pedestrians was improved here using pinchpoints constructed with interim materials.

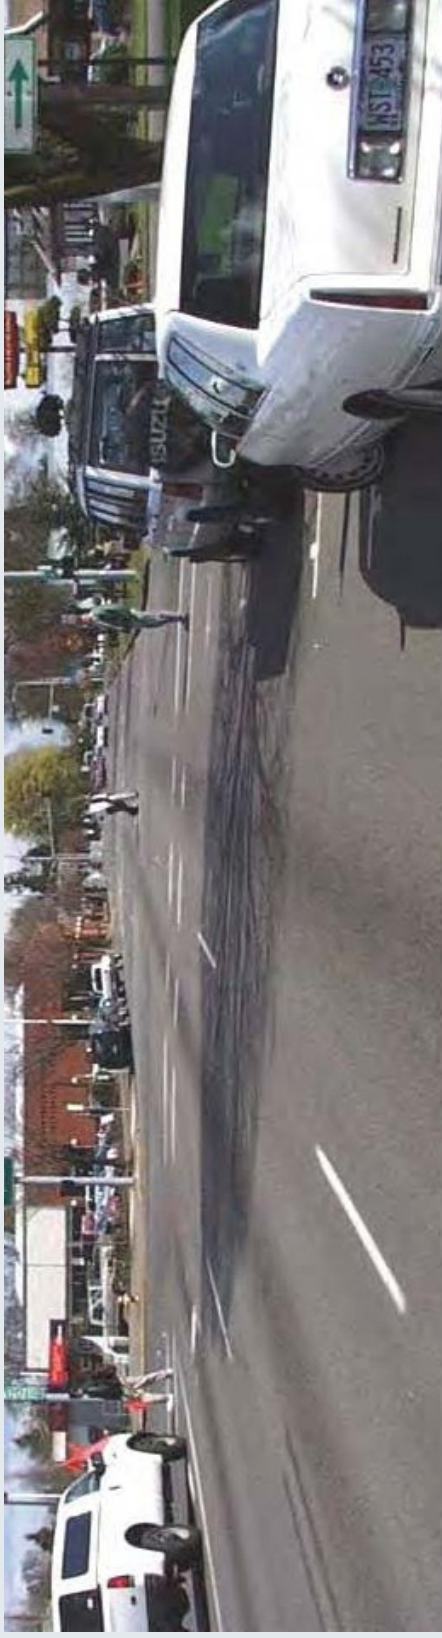
**Pedestrians wait where they can see - in front of parked cars**

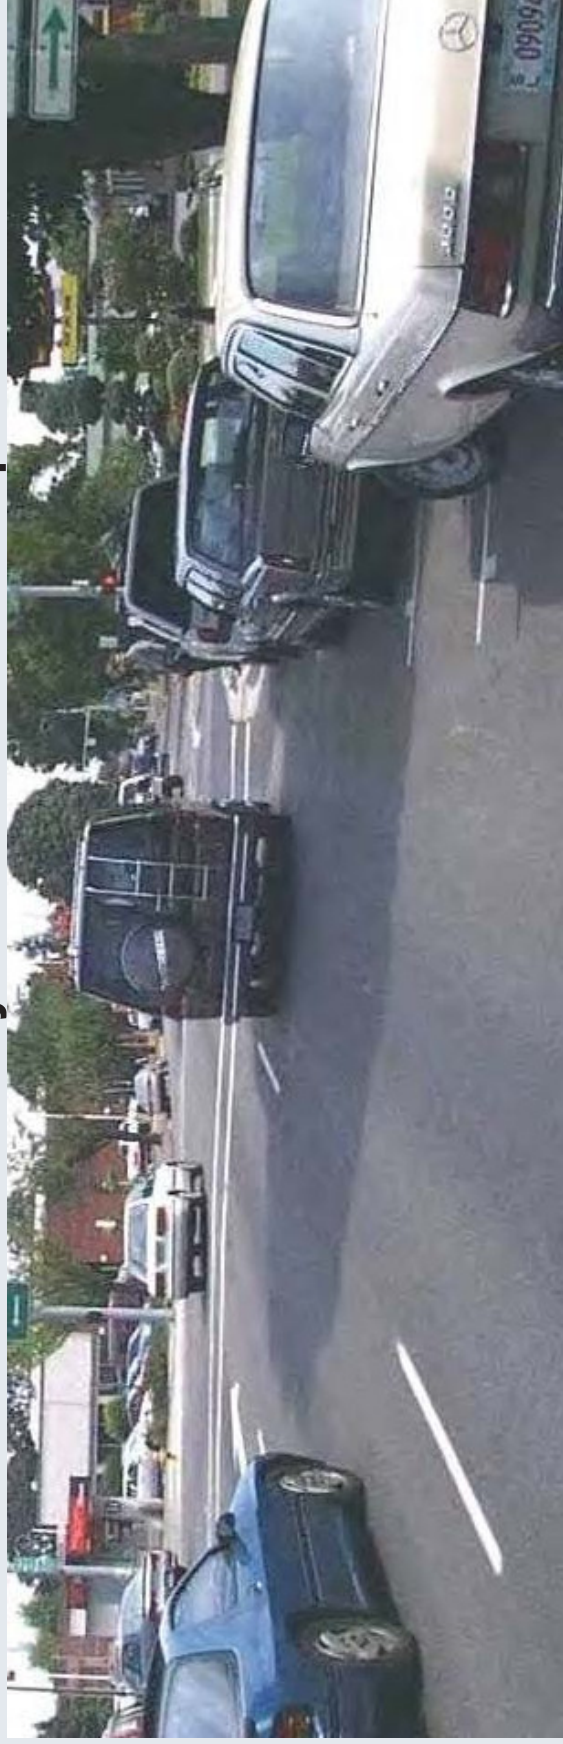
**Curb extension places pedestrian where they can see and be seen!**

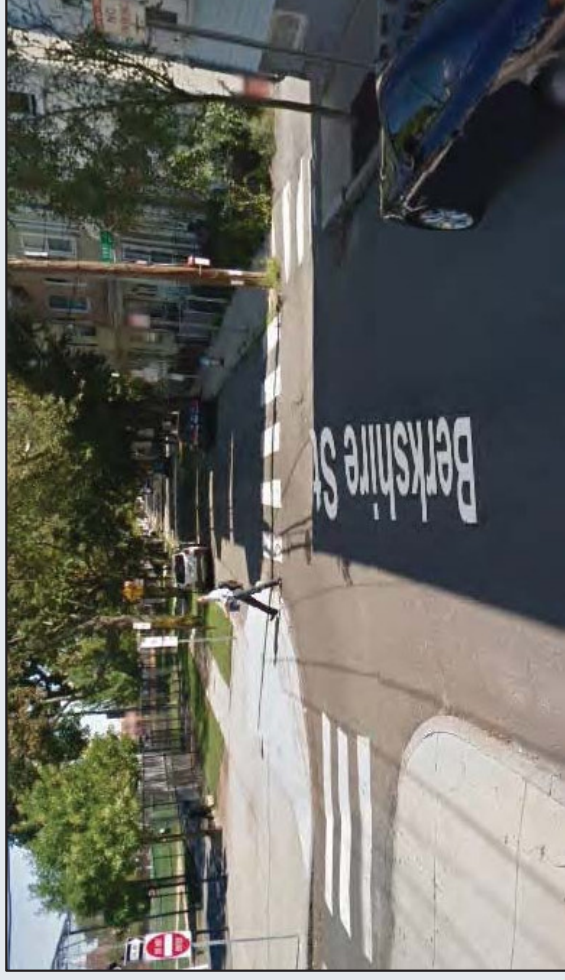
Curb Extension at Berkshire St & York St

- Curb extensions reduced the crossing distance, limited exposure time, improved visibility, & slowed turning vehicles
- Survey found 44% liked the changes, 28% did not
- 47% felt pedestrian safety improved
- 61% said it was more difficult to find parking (despite net loss of 1 on-street space)

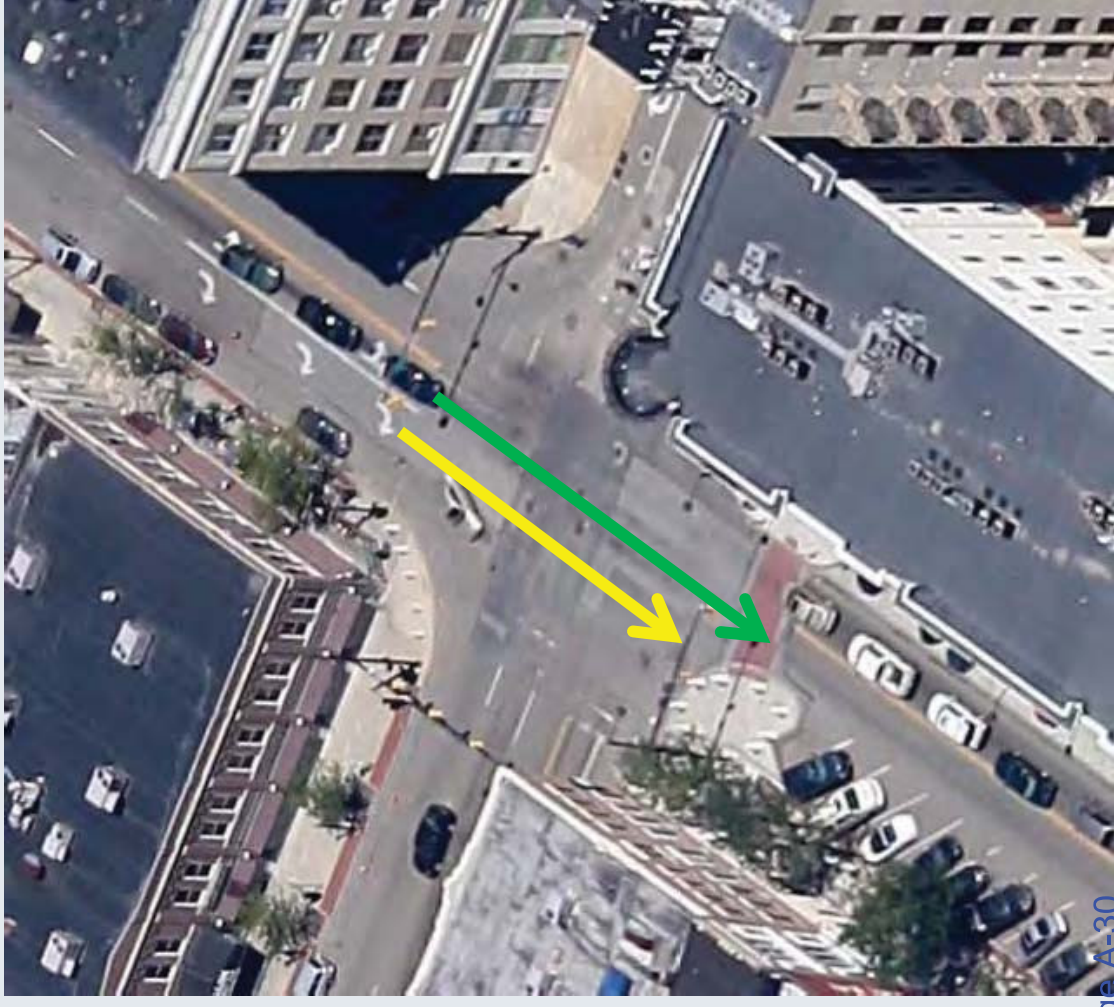
# CURB EXTENSIONS ON ONE SIDE OF INTERSECTION

- Use Caution: Drivers that may run through the right turn lane on one side will hit the curb extension
- Bollards installed to help alleviate the situation

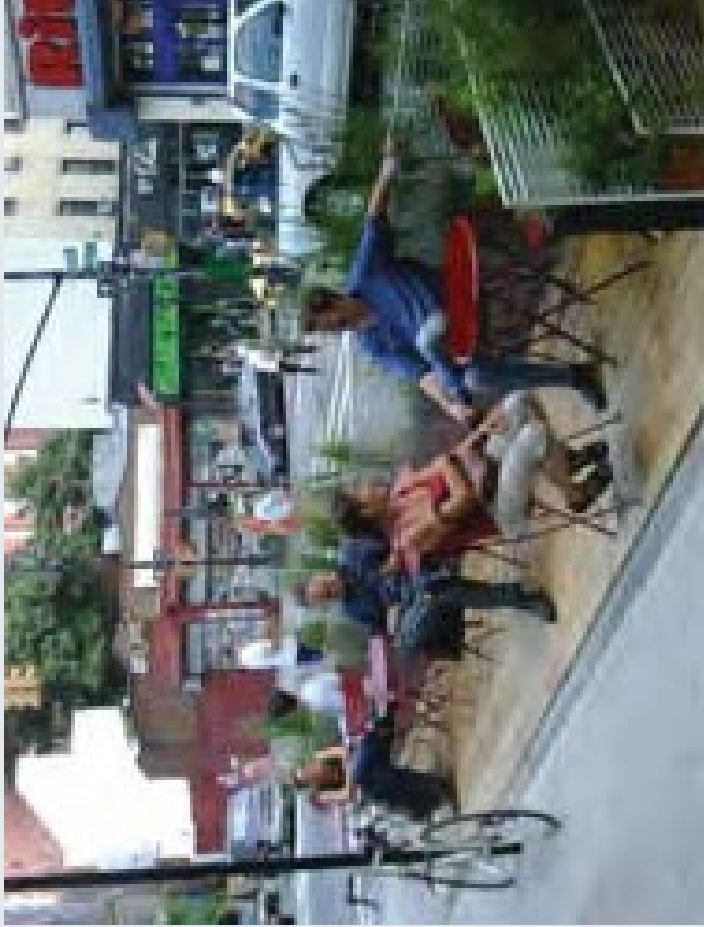
Warren & Smith Streets, Brooklyn DOT

**Bollards, planters, & other fixed objects may be placed at the back of curb to protect pedestrians and prevent vehicles from driving onto the sidewalk.**

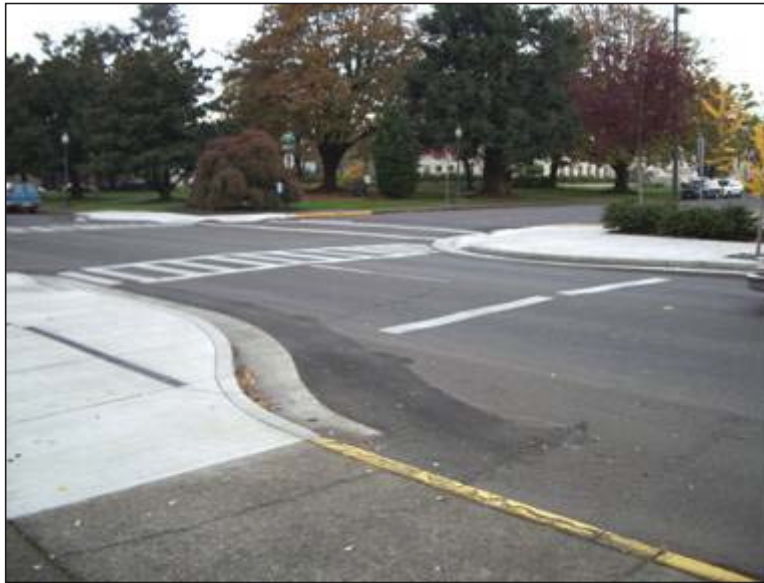
Figure 1.1: Crosswalk with continental marking and advance stop bars

The advance stop bars (Figure 1.1) are also evaluated in this study as a pedestrian safety feature. An advance stop bar is a stripe that is placed up to 20 or more feet upstream from the crosswalk.

A common pedestrian safety hazard that occurs on a one-way multi-lane street is when the motorist in the near lane yields at the edge of the crosswalk marking. This blocks the view of the pedestrian already in the crosswalk from the motorist in the far lane, often resulting in a failure to yield and an increase in the potential for a pedestrian-vehicle collision. This type of collision is known as a “multi-threat” collision (Zegeer, *et al.* 2001). The use of advance stop bars encourages the near lane driver to yield farther back from the crosswalk, thus maintaining a safe stopping sight distance for the motorist in the far lane.
